# CARLYON BEACH HOA

Olympia, Washington

### LEVEL 2 RESERVE STUDY UPDATE WITH A SITE VISIT

Issued April, 2019

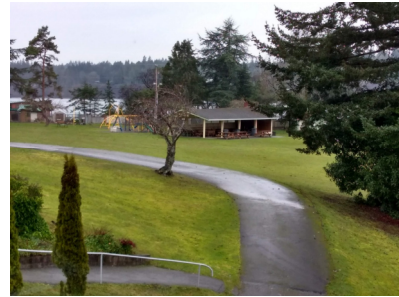
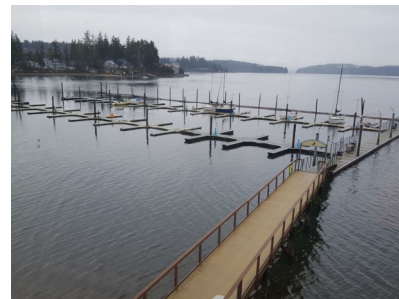
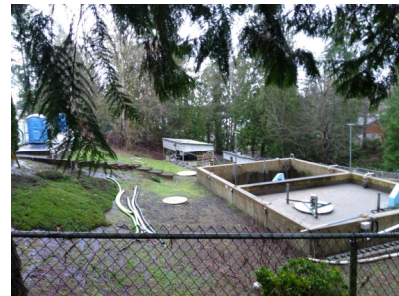
The overall appearance of the community was good. The asphalt paving is maintained yearly and seemed to be in good condition overall. The grounds and landscaping seemed to be regularly maintained.

The exterior siding of the clubhouse was maintained in 2018 and appeared to be in good condition; the paint on the siding and trim was weathering as expected.

No problems were reported with the potable water system, the sewage facility, the plumbing, electrical or drainage systems. Minor and major repairs have been conducted on a regular basis.
